sunrise
energy metals

2022 ENVIRONMENTAL MONITORING RESULTS

AIR QUALITY - JULY

Premises:
Sunrise Project
Wilmatha Road
Fifield, NSW, 2875

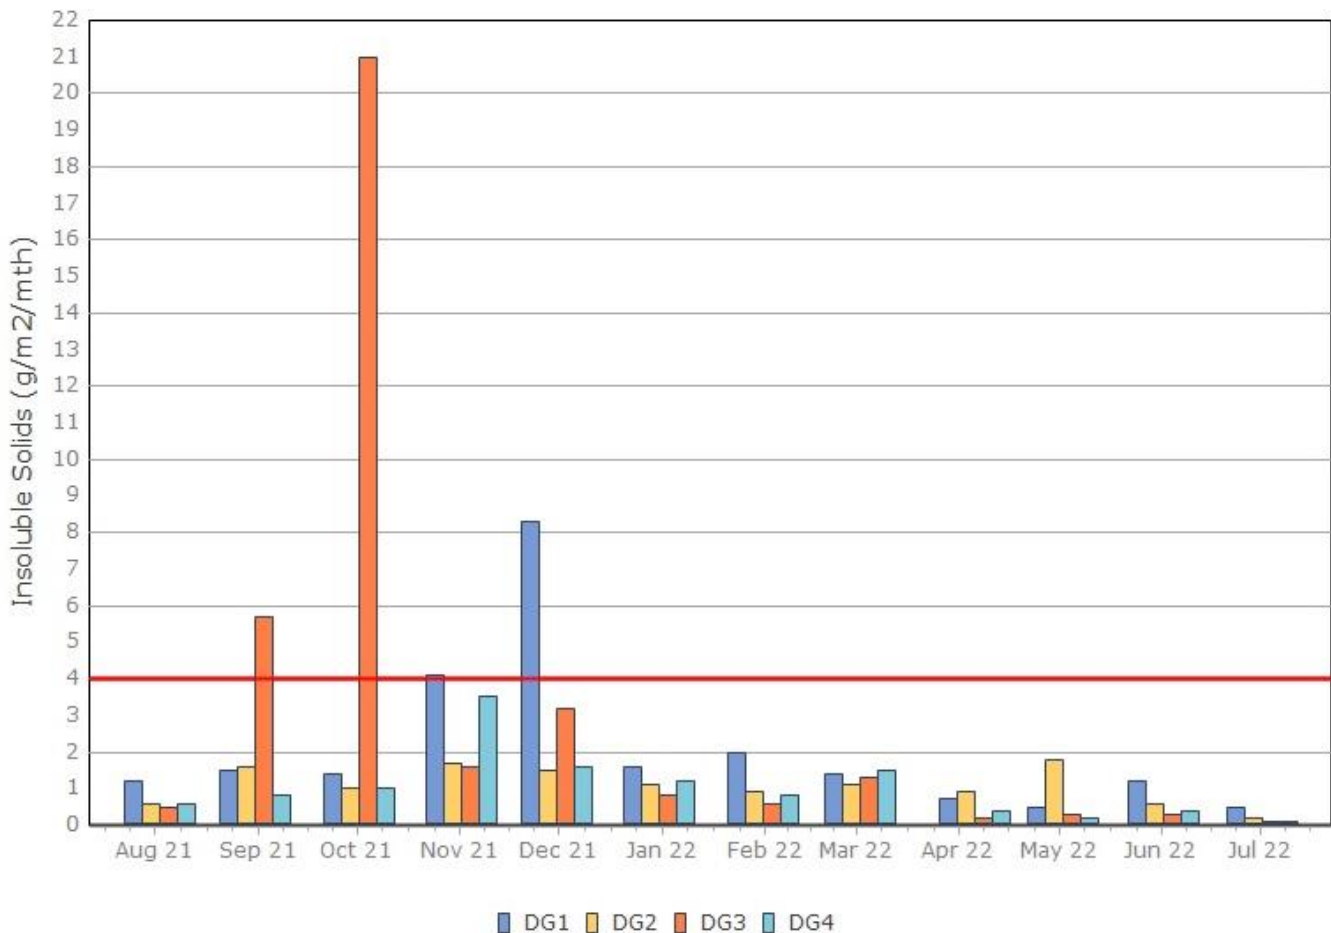
Figure 1. Dust Deposition over the last 12 months with guideline criteria

Month	Sample Period	Results		Insoluble Solids (g/m ² /mth)			
		Received	Published	DG1	DG2	DG3	DG4
January	31/12/21 - 31/1/22	11/2/22	25/2/22	1.6	1.1	0.8	1.2
February	31/1/22 - 1/3/22	11/3/22	21/3/22	2.0	0.9	0.6	0.8
March	1/3/22 - 5/4/22	21/4/22	36/4/22	1.4	1.1	1.3	1.5
April	5/4/22 - 2/5/22	20/5/22	26/5/22	0.7	0.9	0.2	0.4
May	2/5/22 - 1/6/22	15/6/22	21/6/22	0.5	1.8	0.3	0.2
June	1/6/22 - 1/7/22	13/7/22	19/7/22	1.2	0.6	0.3	0.4
July	1/7/22 - 1/8/22	15/8/22	24/8/22	0.5	0.2	0.1	<0.1
August							
September							
October							
November							
December							
Average (Mean)				1.1	0.9	0.5	0.8
Median				1.2	0.9	0.3	0.6
Maximum				2.0	1.8	1.3	1.5
Minimum				0.5	0.2	0.1	0.2

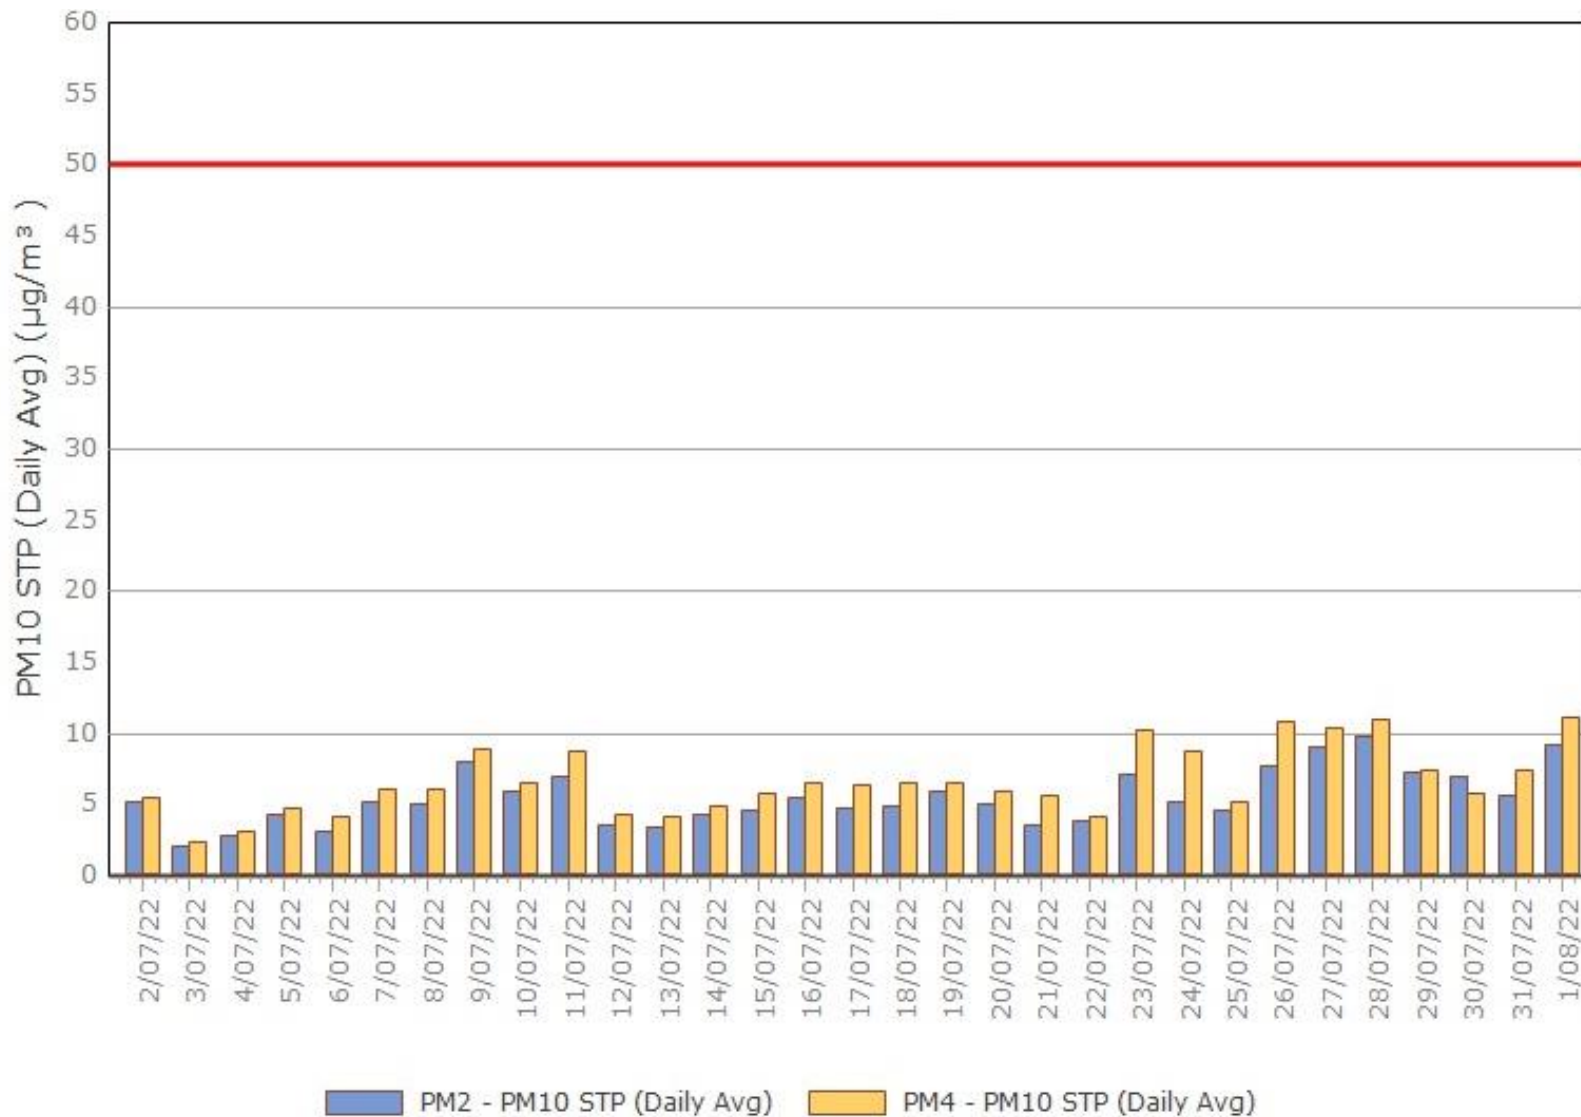
Figure 2. PM10 (24 hr Average) with Compliance Criteria – July 2022

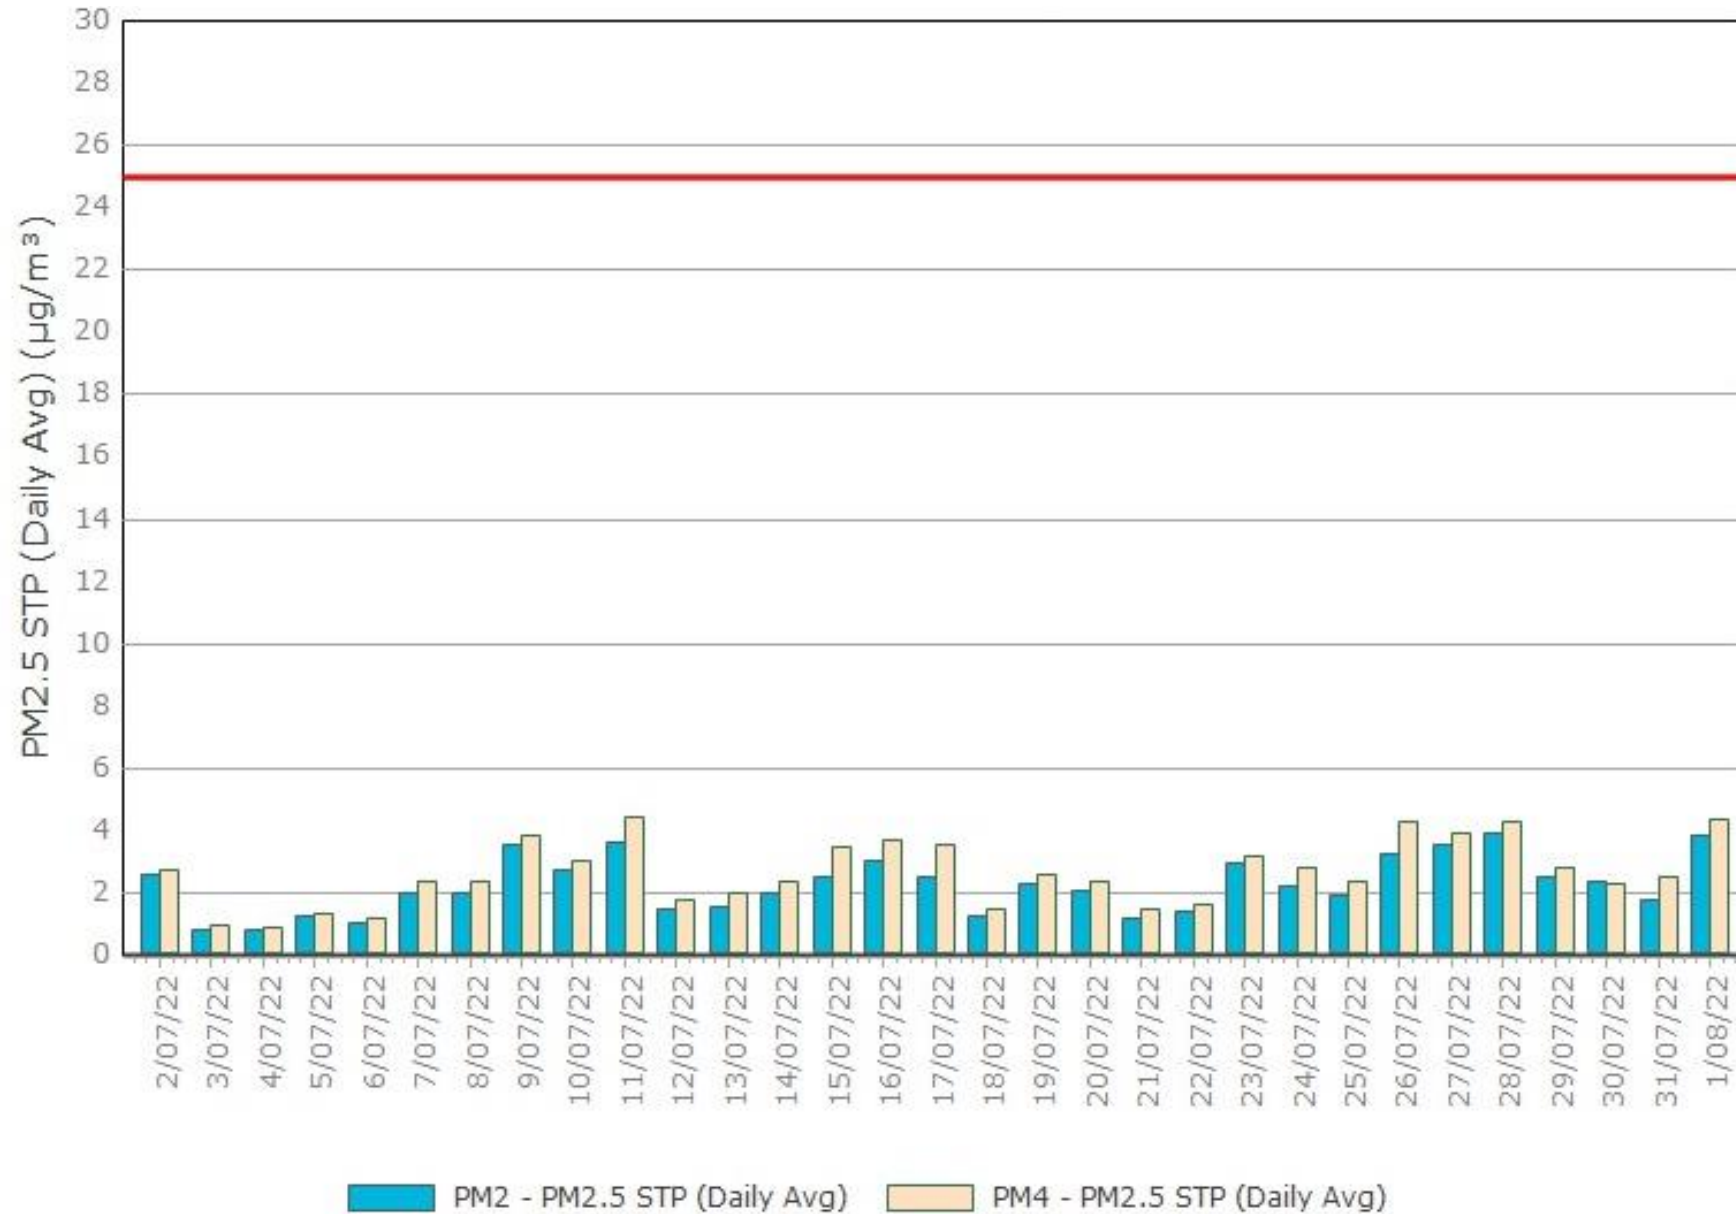
Figure 3. PM2.5 (24 hr Average) with Compliance Criteria – July 2022
